Manhole Inspection Summary

Manhole # S55G__002MH

Insp Date: **4/22/08 10:49 AM**

Location Address: **3401 gough street**

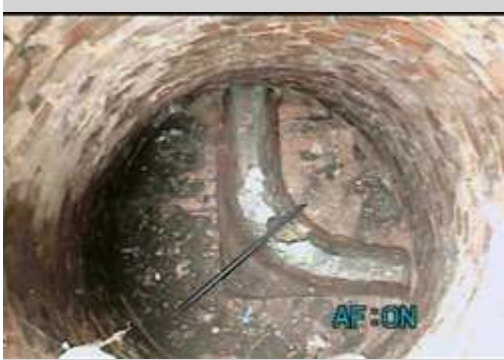
channel debris

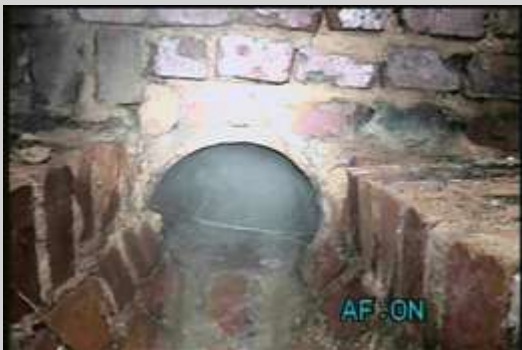
12 O'Clock Outflow

8 in. Circular Gravity Sewer
Pipe Out @ 12 O'Clock

Invert Depth: 7.20 (ft.) Flow Characteristics: **Slow**

Deposits: ☒ None ☐ Mud ☐ Sludge ☐ Debris ☐ Grease

Infiltration: **None** Pipe Seal Cond: **Unknown**

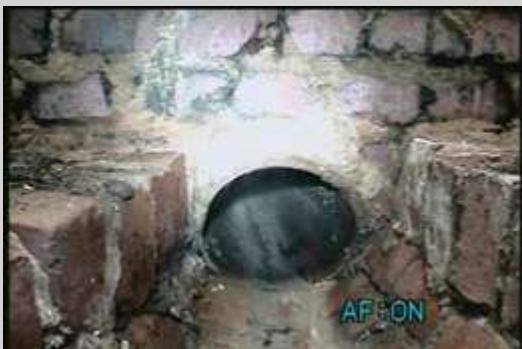
3 O'Clock Inflow

8 in. Circular Gravity Sewer
Pipe In @ 3 O'Clock

Invert Depth: 7.00 (ft.) Flow Characteristics: **Slow**

Deposits: ☒ None ☐ Mud ☐ Sludge ☐ Debris ☐ Grease

Infiltration: **None** Pipe Seal Cond: **Unknown**

Connects To: **House connection / Service line**
